UPPER AND LOWER LITTLE RIVER DAMS DAM ASSESSMENT REPORT

PREPARED FOR RANSOM CONSULTING, INC.

JULY 2018

WRIGHT-PIERCE

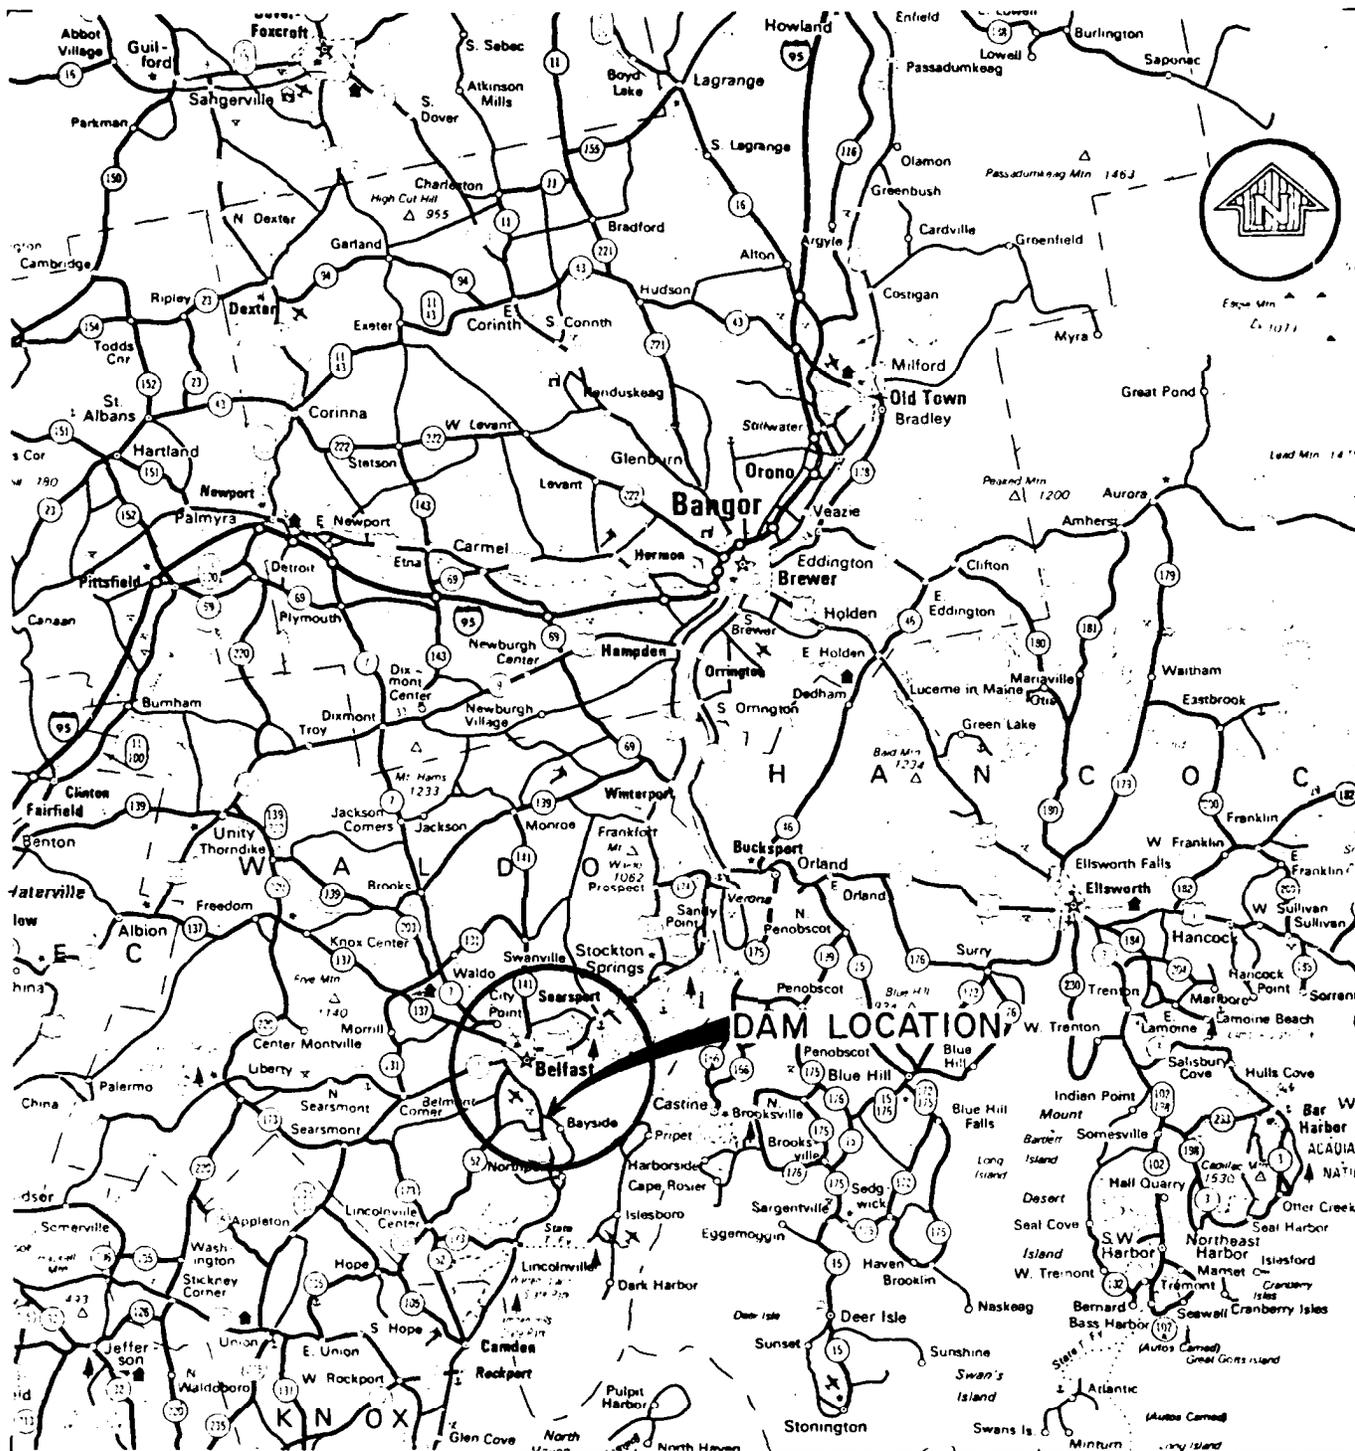
Figure 1 - Overview of Little River Lower Dam.
