Technical Memo

Date: September 12, 2012
To: Thomas Kittredge, City of Belfast
From: Kristin Gill, Erik Phenix, and Peter Sherr, Ransom Consulting, Inc.
cc: Tracy Kelly and Molly King, MEDEP
AmyJean McKeown, US EPA
Subject: **Conceptual Remedial Action Plan and Cost Estimate
Belfast Boatyard, 38 Waterville Road, Belfast, Maine**
Project No: R111.06134

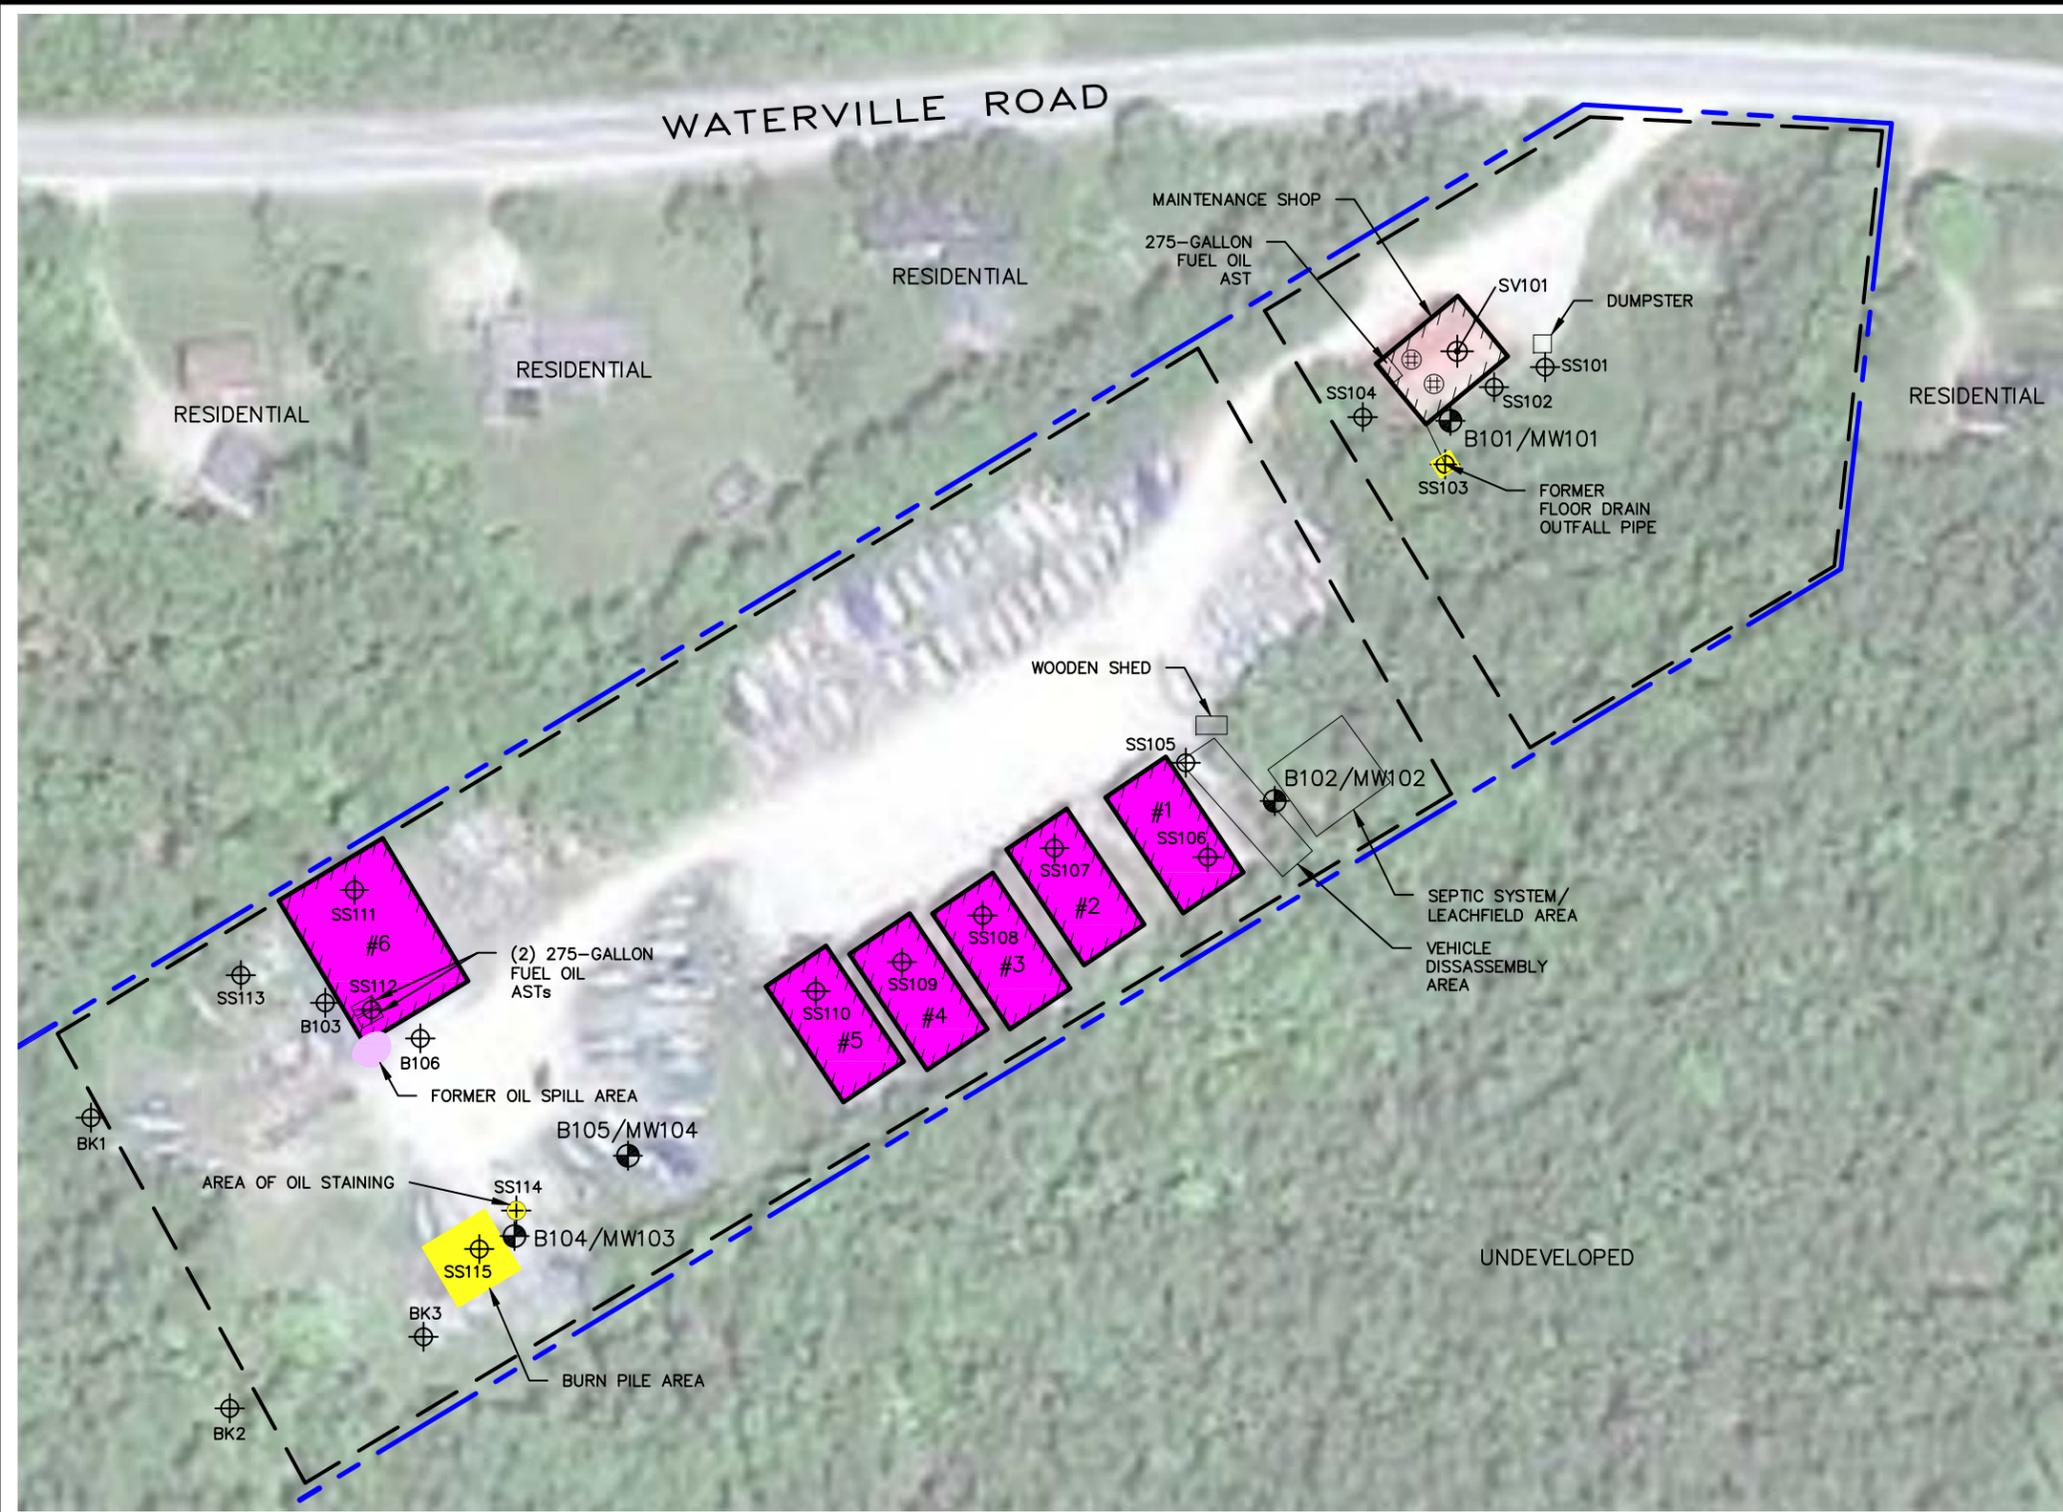
As shown on the attached Figure 1, cover systems are proposed to be installed over the dirt floors of Storage Structures No. 1 through No. 6. The cover systems will be designed to prevent direct contact exposure to contaminants of concern identified at the Site. The cover systems are proposed to be asphaltic pavement cover systems consisting of a minimum of 3 inches of reclaimed asphalt pavement (approximately ¾-inch crushed reclaimed asphalt) over a geotextile fabric marker layer. The marker layer will indicate the extent of clean materials above the contaminated materials.

As shown on the attached Figure 1, limited soil removal activities are proposed to be conducted within the burn pile area (approximately 900 square feet), the area of oil staining (approximately 65 square feet), and south of the Maintenance Shop (approximately 120 square feet) on the Site. Soils are proposed to be excavated to a depth of approximately two feet below the ground surface. A total of approximately 80 cubic yards of impacted soils are proposed to be excavated from these three areas and disposed off-site as special waste (i.e., non-hazardous).

- **Burn Pile:** An elevated concentration of arsenic was detected in the surficial soil sample collected from the burn pile (located in the vicinity of SS-115 on Figure 1), which exceeded its background concentrations and MEDEP RAGs for both “Outdoor Commercial Worker” and “Excavation/Construction Worker” exposure scenarios. The presence of this elevated arsenic concentration is likely associated with combustion of arsenic-containing wood at the burn pile portion of the Site. It should be noted that arsenic was detected at concentrations exceeding the corresponding “Outdoor Commercial Worker” and “Excavation/Construction Worker” RAGs in additional soil samples collected throughout the Site; however, with the exception of the sample collected from the burn pile area, these arsenic concentrations appear to represent background conditions for the fill material placed for site grading and are below the draft State-wide background arsenic concentration for rural areas, and therefore, do not appear to represent an exposure risk for future boatyard workers.

Storage Structures No. 1 through No. 5 encompass footprints of approximately 3,200 square feet each, and Storage Structure No. 6 encompasses a footprint of approximately 6,030 square feet.
