UPPER AND LOWER LITTLE RIVER DAMS DAM ASSESSMENT REPORT

PREPARED FOR RANSOM CONSULTING, INC.

JULY 2018

WRIGHT-PIERCE

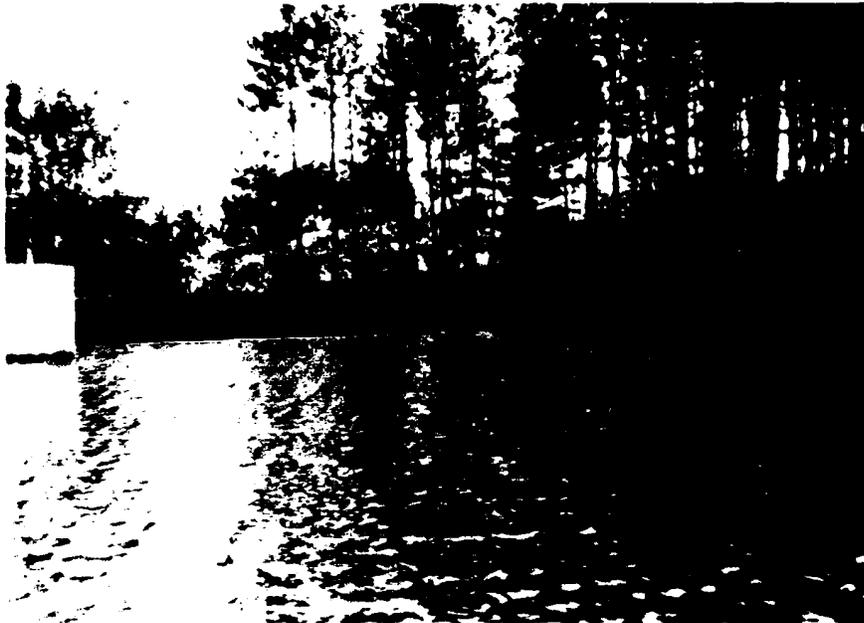
September 17, 1979
Figure 3 - View of upstream face of Little River
Upper Dam.

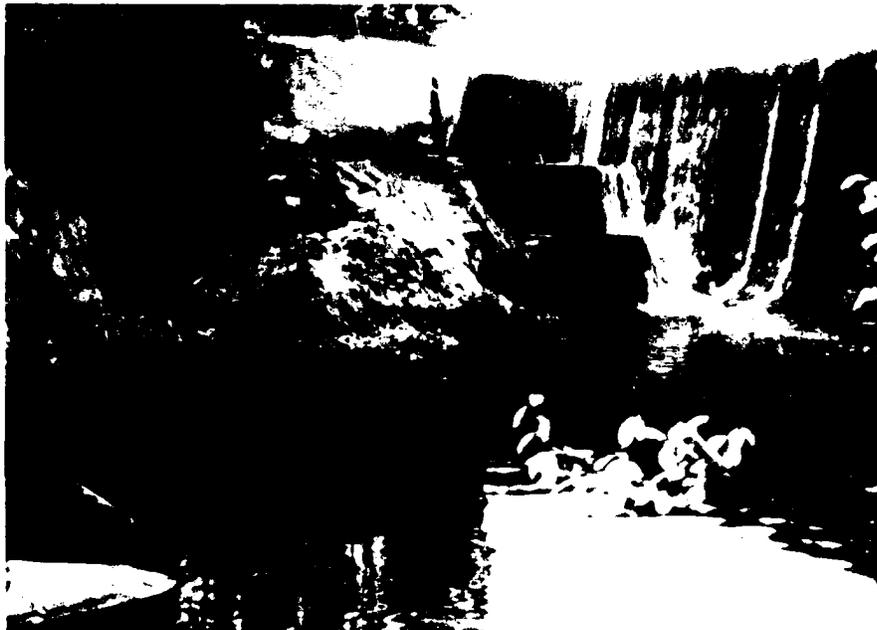
September 17, 1979
Figure 5 - Downstream face of south abutment.

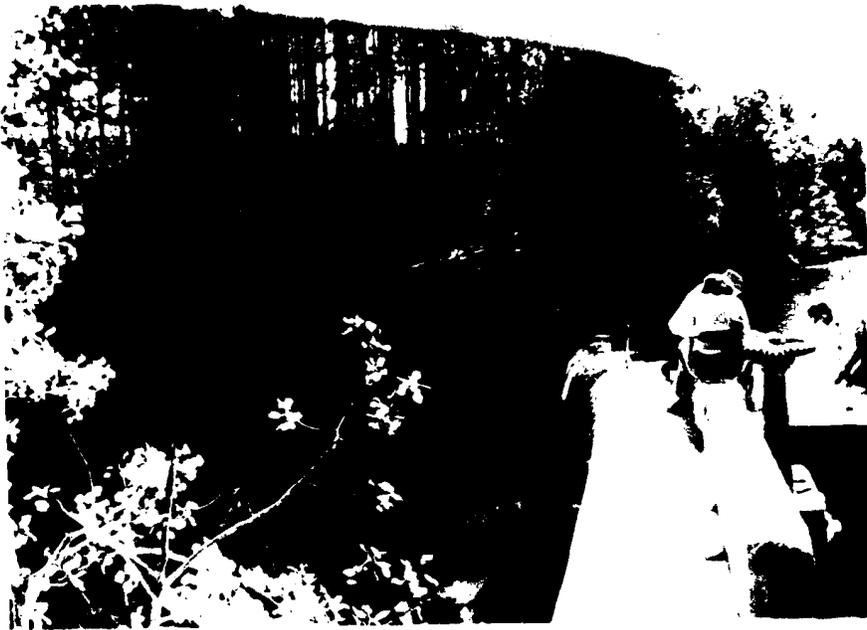
overflow section of the dam. Brush and small trees are growing on the upstream slope. (See Appendix C - Figures 7 & 8.)

Figure 8 - Looking across crest from north abutment of the dam.

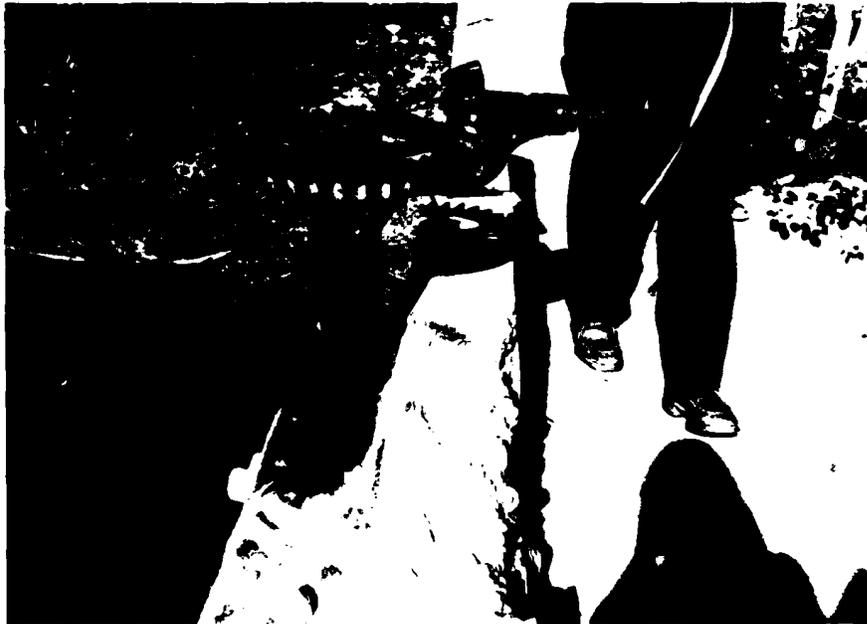
Approximately 2 feet to the north of the control tower (intake structure) there is an intermediate level outlet gate operating mechanism. (See Appendix C - Figure 11.) The shaft and steel bearing attached to the upstream face of the dam are coated with gunite. The gate operating mechanism has not been maintained and does not appear operable. The Belfast Water Department Assistant Superintendent reports that the gate has not been operated in many years. An 18-inch clay tile pipe discharges from the downstream face of the dam in line with the gate operating mechanism. (See Appendix C - Figure 6.) Water is discharging from the 18-inch clay tile line at an estimated rate of 15 to 30 gpm.

September 17, 1979
Figure 11 - View of gate mechanism at the north
abutment.

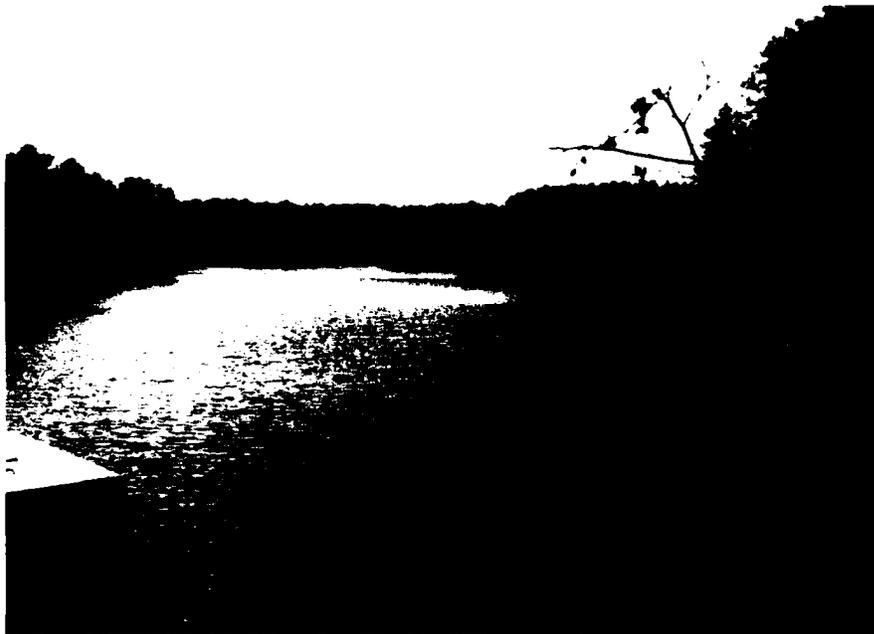
d. Reservoir Area. The watershed above the reservoir is rolling and partially wooded. (See Appendix C - Figure 12.) No structures were observed on the shore of the reservoir. No evidence of significant sedimentation in the reservoir was observed.

September 17, 1979
Figure 12 - Looking upstream at the reservoir from the
top of the north abutment.

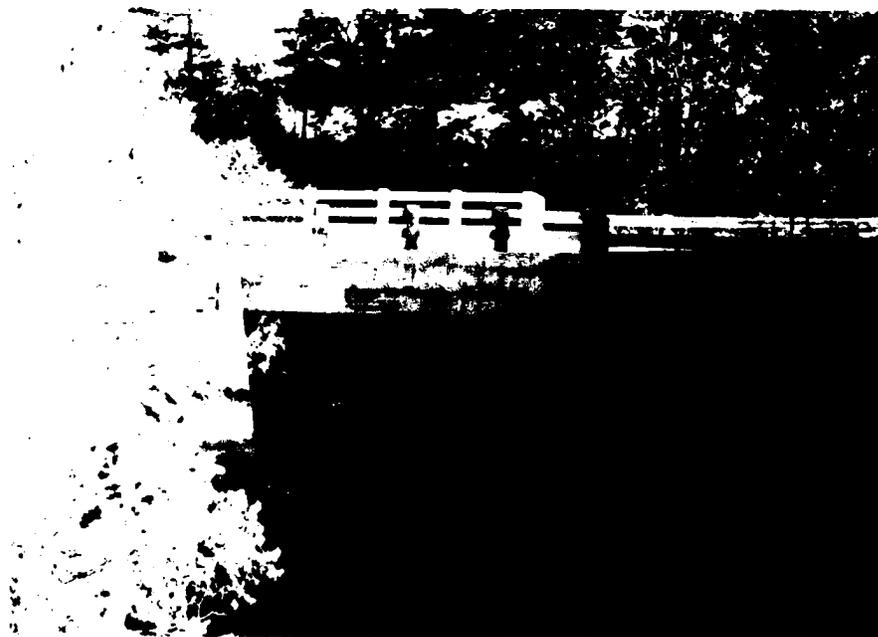
e. Downstream Channel. The channel downstream of the dam appears to be on bedrock. The south bank of the channel is bedrock, but the left bank is soil. Trees and brush overhang the left side of the channel. Herrick Road bridge crosses the channel 200 feet downstream from the dam. (See Appendix C - Figures 13 & 14.)

September 17, 1979
Figure 13 - Herrick Road Bridge 200' downstream of
the dam.

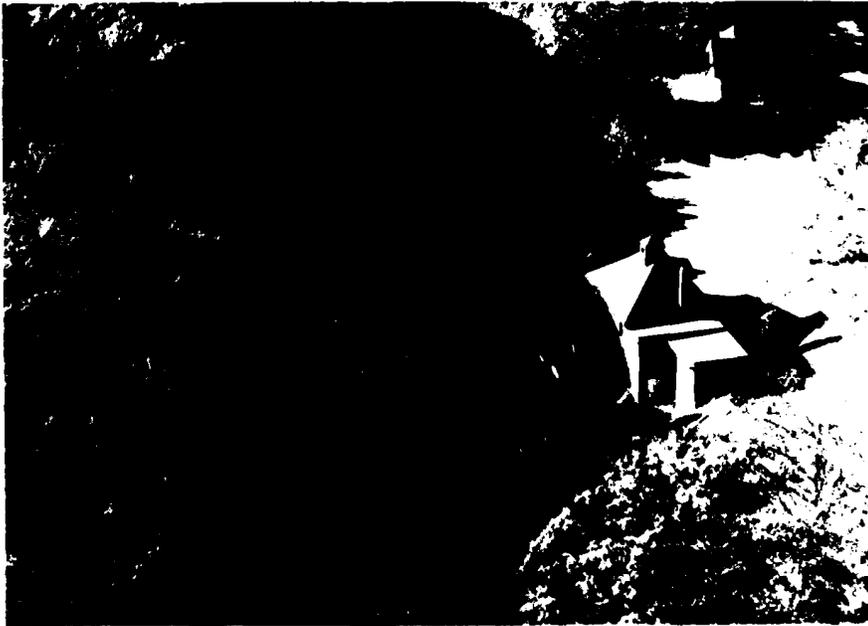
Figure 1 - Overview of Little River Lower Dam.

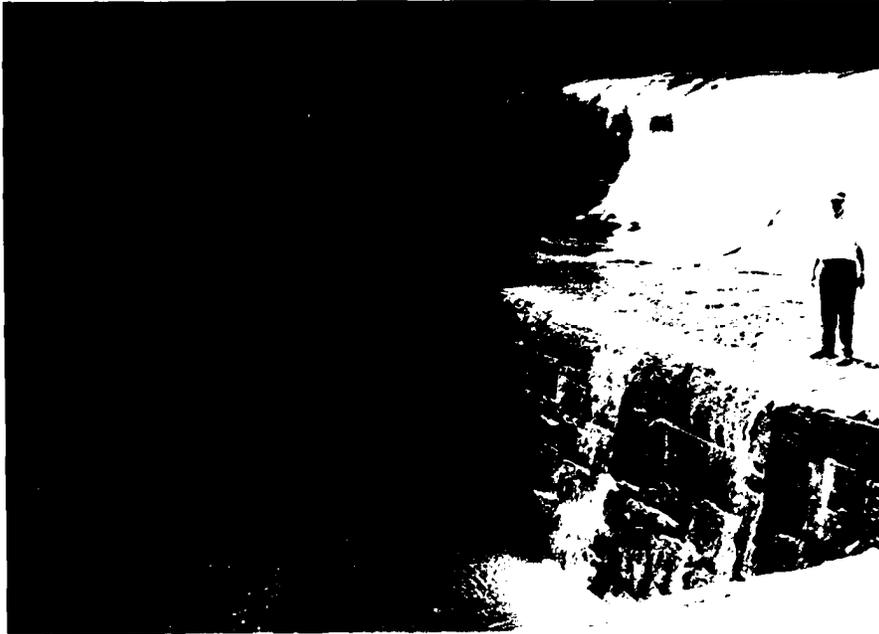
September 17, 1979
Figure 2 - Downstream face of the dam.

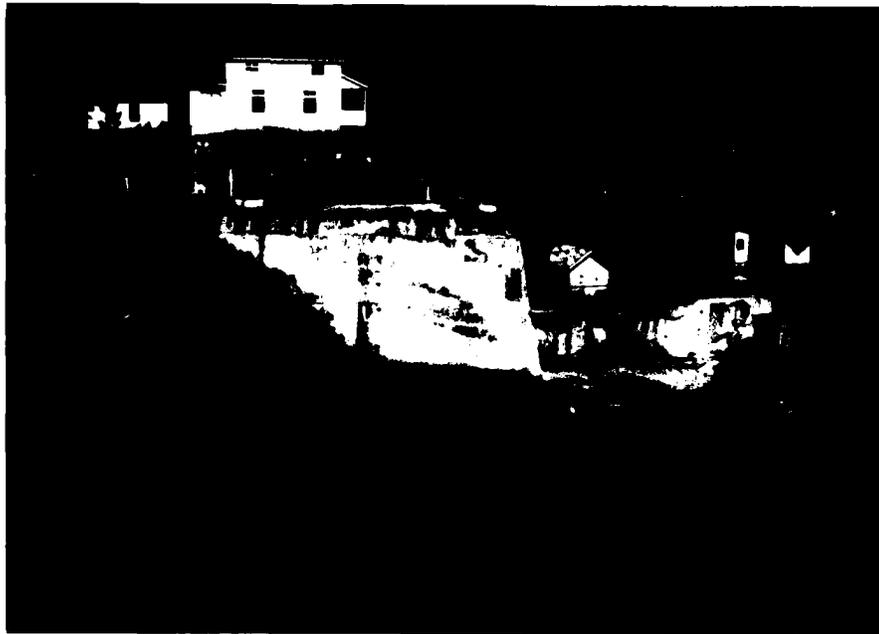
At the north end of the dam there is a massive intake structure which appears to be dry-stone-masonry encased in concrete on the top, upstream face, and river-side face. (See Appendix C - Figures 3 & 4.) The downstream face is dry-stone-masonry. (See sketch plan, Appendix B.)

September 17, 1979
Figure 3 - Looking across the crest at north abutment.

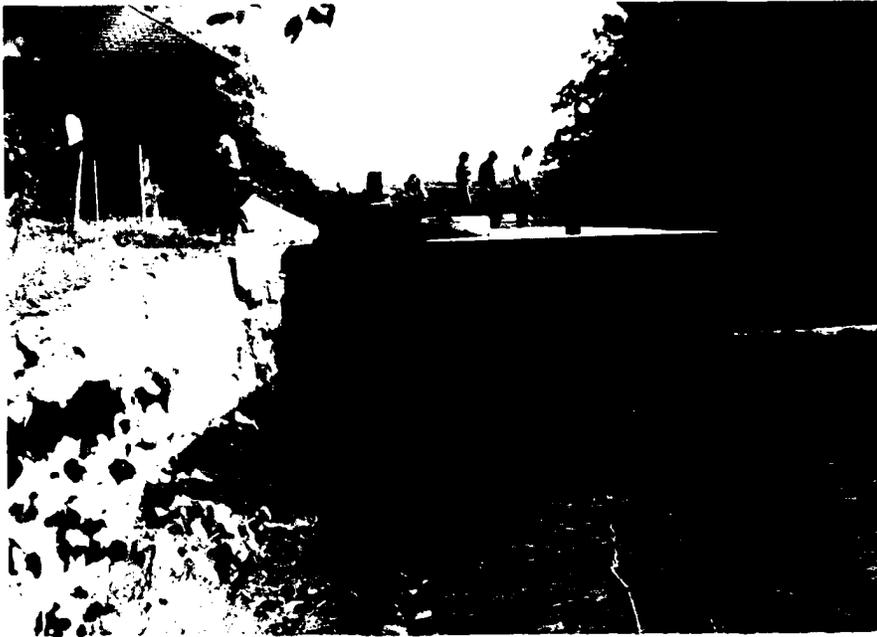
c. Appurtenant Structures. A stone masonry training wall, partially faced with concrete which is in poor condition, supports the north bank of the upstream approach channel. (See Appendix C - Figure 8.)

September 17, 1979
Figure 8 - View of upstream side of the north
abutment.

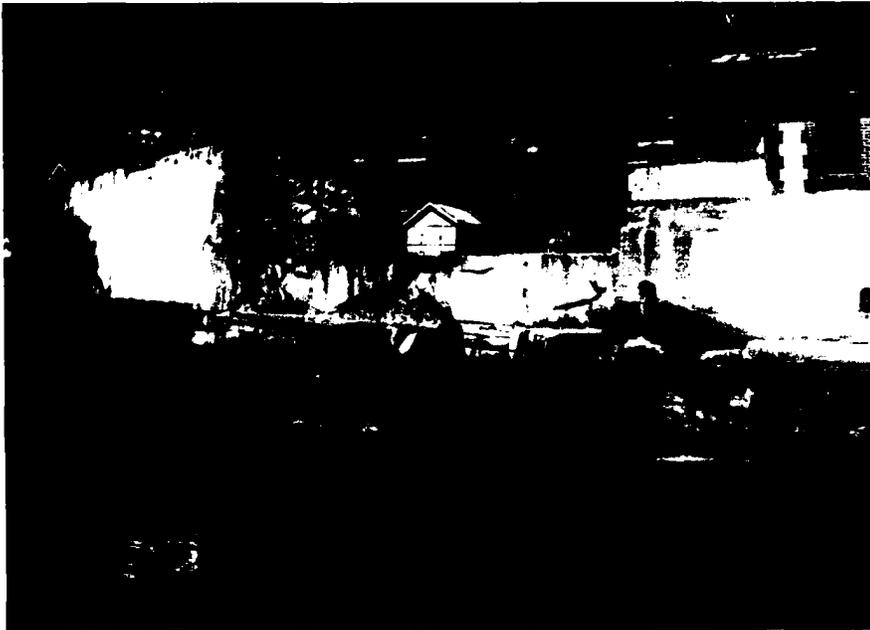
the approximately 8-inch thick concrete cap which is severely cracked. (See Appendix C - Figure 9.)

A 5-foot-diameter steel pipe exits at the bottom of the training wall on the north bank of the downstream channel. The outlet of the pipe is plugged with sand and gravel to about one-third of its height. (See Appendix C - Figure 9.) The gate mechanism on the north abutment is inoperable; the gate size is unknown. (See Appendix C - Figure 4.) The mechanism is in poor condition with no indication of maintenance. A pump station building and a filter house for a water supply system is located integrally with the north abutment. A concrete wall which exists on the river side of these buildings is an extension to the downstream retaining wall. (See Appendix C - Figure 10.)

September 17, 1979
Figure 9 - Dry-stone-masonry wall at north bank of
the downstream channel.

- (2) Clear the sand and gravel that partially block the discharge end of the low-level outlet pipe.
- (3) Inspect visually the dam and appurtenant structures once a month.
- (4) Engage a Registered Professional Engineer to make a comprehensive technical inspection of the dam once a year.
- (5) Establish a surveillance program for use during and immediately after heavy rainfall and also a warning program to follow in case of emergency conditions.

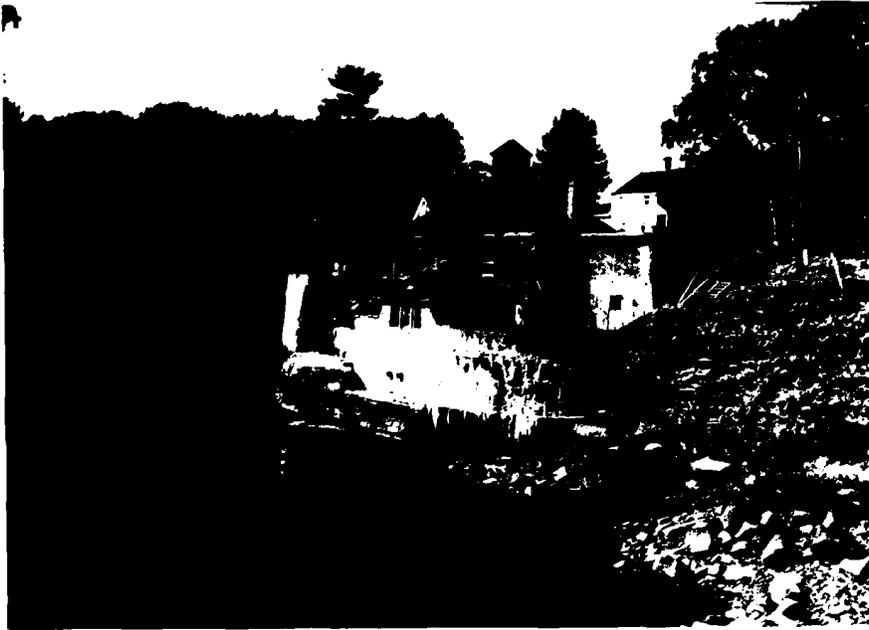
September 17, 1979
Figure 10 - View of the north bank of the downstream
channel from the U.S. Route 1 bridge.

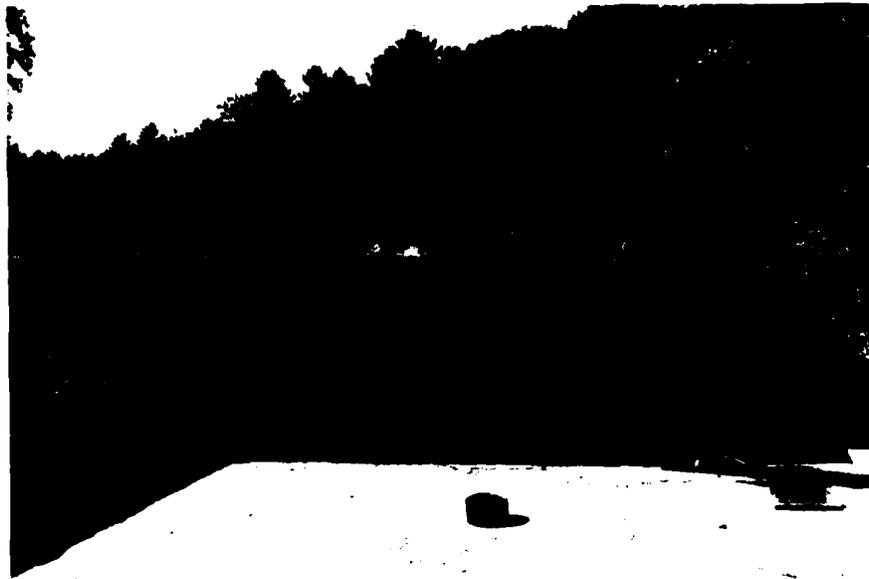
d. Reservoir Area. The watershed above the reservoir is rolling and partially wooded. (See Appendix C - Figure 11.) No structures were observed on the shore of the reservoir. No evidence of significant sedimentation in the reservoir was observed.

September 17, 1979
Figure 11 - Looking upstream at the reservoir from
the north abutment.
